**UPPER PATUXENT RIVER WATERSHED RESTORATION ACTION STRATEGY (WRAS)  
FORM 1 -- Catchment Information**

Subwatershed: Bear Branch

**UPPER PATUXENT RIVER WATERSHED RESTORATION ACTION STRATEGY (WRAS)  
FORM 2 -- Site Information**

Site Name: Granville Gude Park and Lakehouse Address: Mulberry Street, Laurel MD 20707

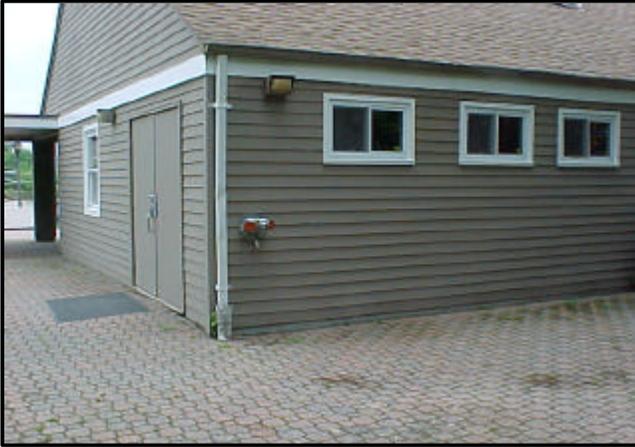
10

No. <u>10</u>	Description: <u>typical location</u>
No. _____	Description: _____

**Comments** Rain barrels and cisterns will be used where feasible. Will also use planter boxes. Downspouts will have to be disconnected.

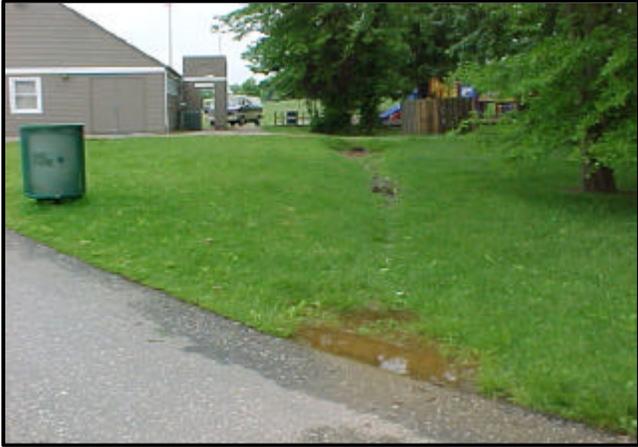
12

No. <u>12</u>	Description: <u>looking east</u>
No. <u>13</u>	Description: <u>looking west</u>
No. _____	Description: _____

**Comments** Area of propped IMP appears to be poorly drained. Underdrains may be needed.  
Less than 17% imperviousness, therefore 1/2 in. of runoff was used  
IMP area = 549 sq ft  
 \_\_\_\_\_  
 \_\_\_\_\_  
 \_\_\_\_\_  
 \_\_\_\_\_

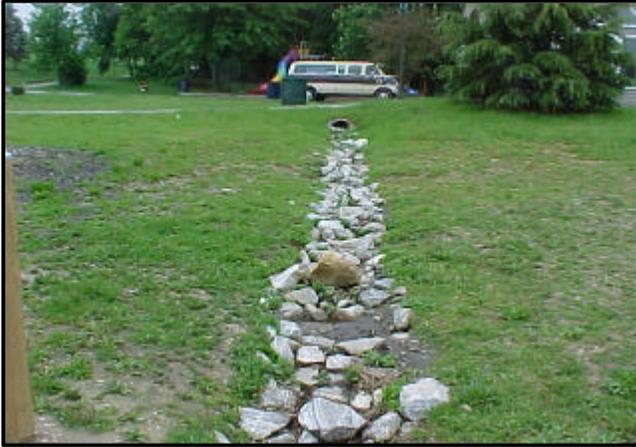
4

No. <u>4</u>	Description: <u>looking south</u>
No. _____	Description: _____

**Comments** Area of propped IMP appears to be poorly drained. Underdrains may be needed.  
Combined with GGPL-7  
IMP size = 803 sq ft  
 \_\_\_\_\_  
 \_\_\_\_\_  
 \_\_\_\_\_  
 \_\_\_\_\_

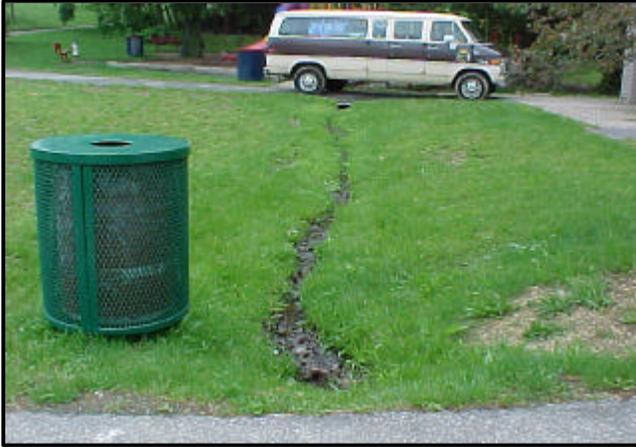
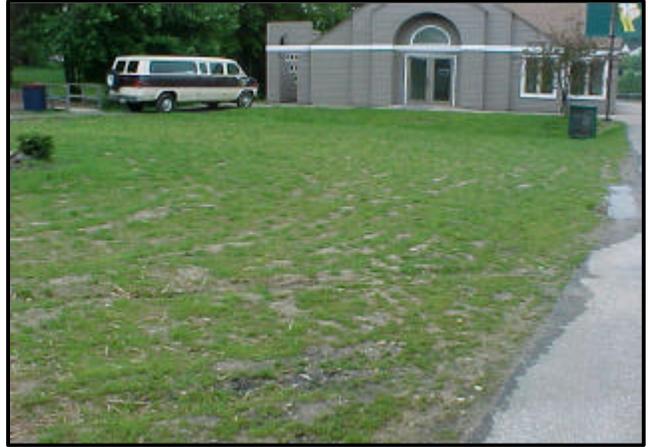
**Comments** Area of proposed IMP appears to be poorly drained. Underdrains may be needed.  
Less than 17% imperviousness, therefore 1/2 in. of runoff was used  
IMP area = 1,666 sq ft  
 \_\_\_\_\_  
 \_\_\_\_\_  
 \_\_\_\_\_  
 \_\_\_\_\_

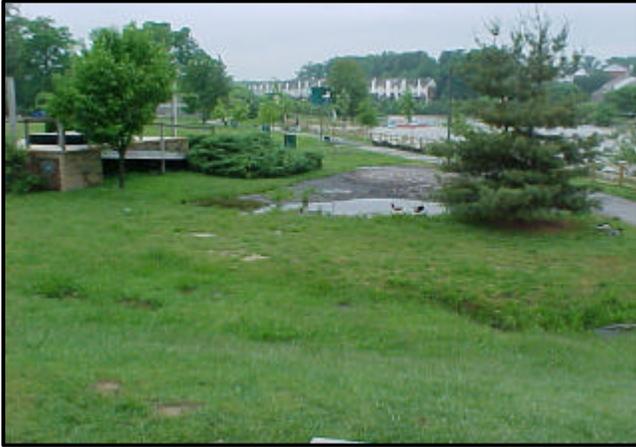
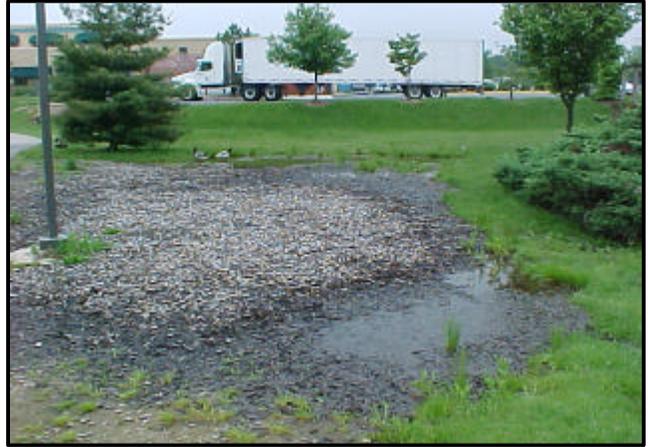
**Comments** Area of proposed IMP appears to be poorly drained. Underdrains may be needed.  
Less than 17% imperviousness, therefore 1/2 in. of runoff was used  
IMP area = 876 sq ft  
 \_\_\_\_\_  
 \_\_\_\_\_  
 \_\_\_\_\_  
 \_\_\_\_\_
